Manhole Inspection Summary

Manhole # S53O__037MH

Insp Date: **4/16/08 8:59 AM**

Location Address: **3121 odonnell**

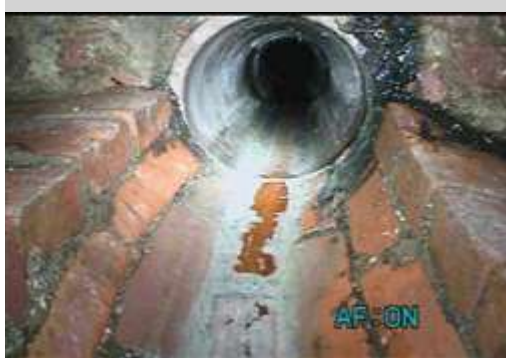
Defect 2

Infiltration: ☐ None ☐ Joint ☐ Cracks ☐ Mortar ☐ Roots ☒ **Wall**

Infiltration in barrel wall near 9 O Clock Pipe

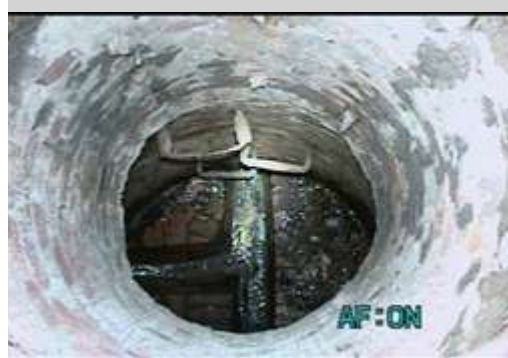
Defect 2

Condition: ☐ Sound ☐ Cracked ☐ Root Intrusion ☐ Loose Brick ☒ **Deteriorated**

Missing: **2**

☒ **Corroded**

chimney deteriorated, corroded steps

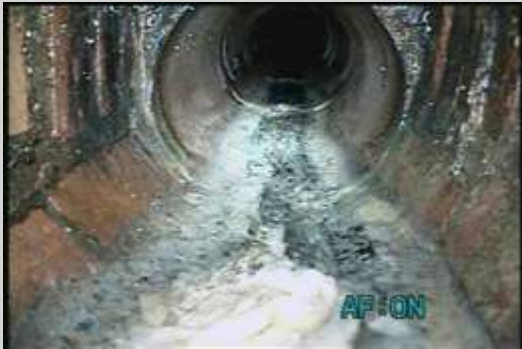
12 O'Clock Outflow

8 in. Circular Gravity Sewer
Pipe Out @ 12 O'Clock

Invert Depth: 9.30 (ft.) Flow Characteristics: **Slow**

Infiltration: **None** Pipe Seal Cond: **Unknown**

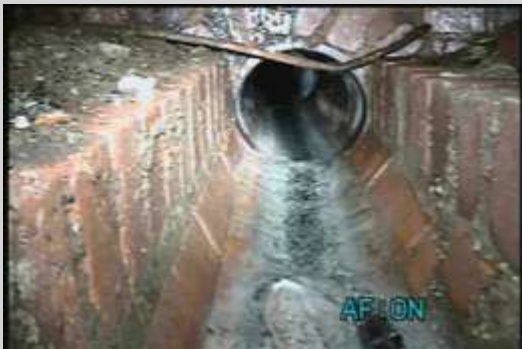
6 O'Clock Inflow

8 in. Circular Gravity Sewer
Pipe In @ 6 O'Clock

Invert Depth: 9.10 (ft.) Flow Characteristics: **Slow**

Infiltration: **None** Pipe Seal Cond: **Unknown**

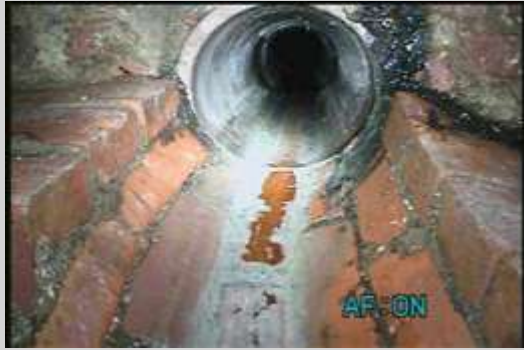
9 O'Clock Inflow

8 in. Circular Gravity Sewer

Pipe In @ 9 O'Clock

Invert Depth: **8.80** (ft.) Flow Characteristics: **Slow**

Infiltration: **None** Pipe Seal Cond: **Unknown**
